MASSACHUSETTS COASTAL BASIN  
COHASSET, MASSACHUSETTS

AARON RIVER DAM  
MA 01280

PHASE I INSPECTION REPORT  
NATIONAL DAM INSPECTION PROGRAM

SEPTEMBER 1980

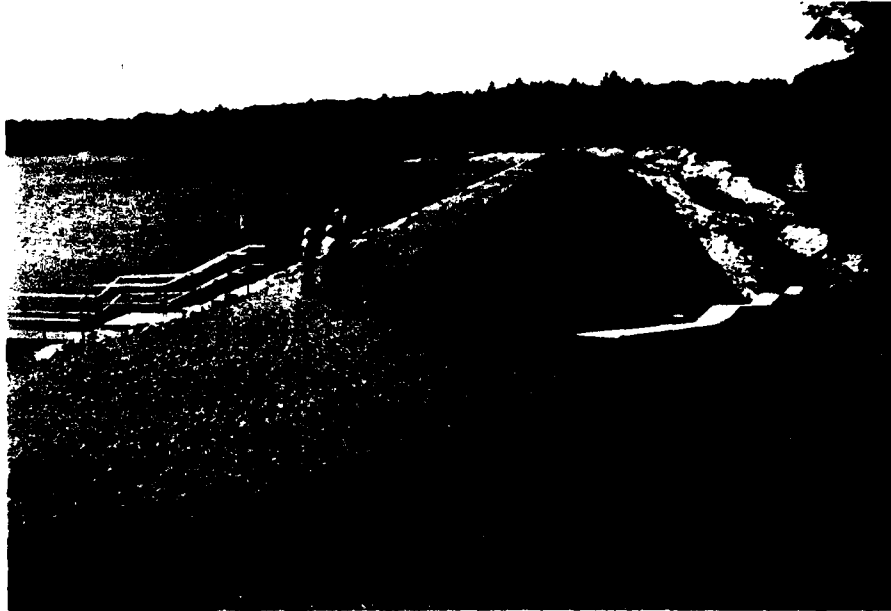
1. OVERVIEW OF DAM FROM RIGHT ABUTMENT.

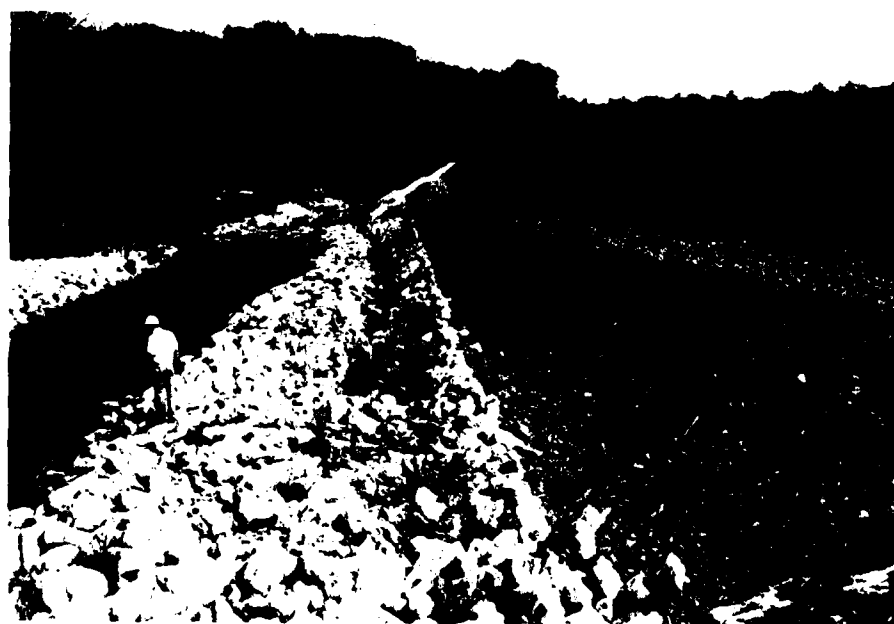
3. DOWNSTREAM FACE OF DAM LOOKING TOWARDS RIGHT ABUTMENT.

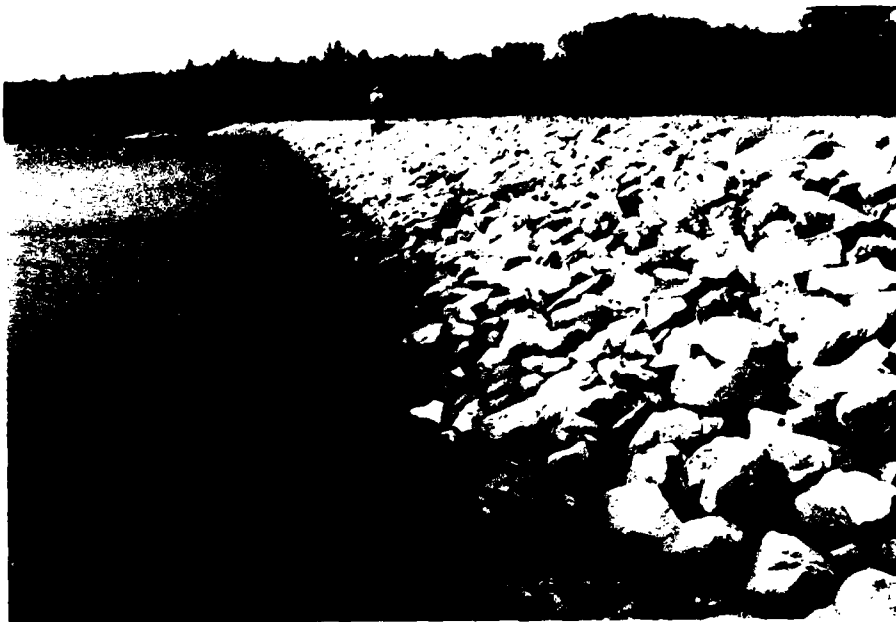
- (2) The upstream riprap wave protection is in generally good condition as indicated by Photo 4. However, a few stones have been dislodged (apparently by trespassers) near the fishway.

1. UPSTREAM FACE OF DAM SHOWING RIPRAP WAVE PROTECTION AND RESERVOIR DRAIN GATE OPERATOR.

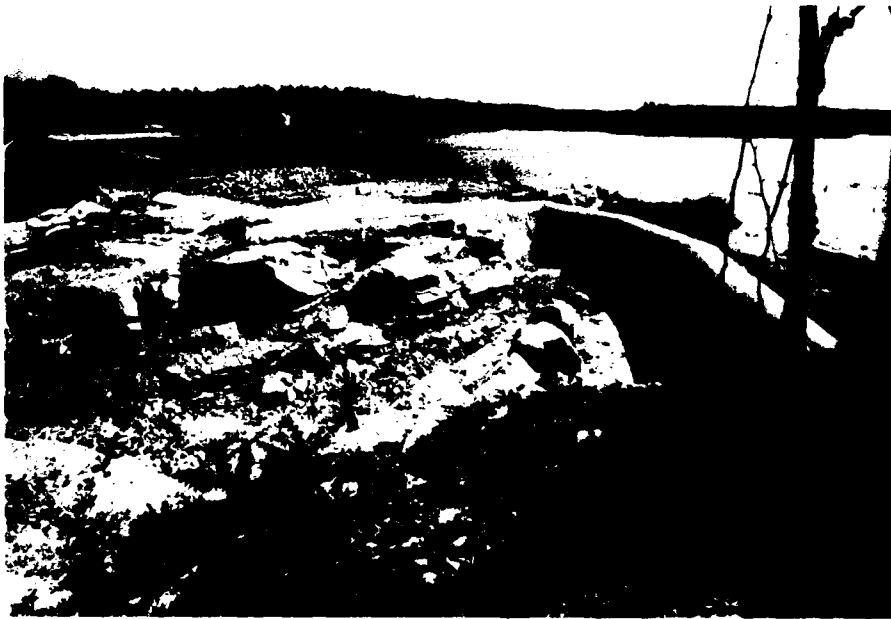
- (1) Two boulders are present in the discharge channel immediately adjacent to the spillway weirs as shown in Photo 5.
- (2) Cracks in the spillay weir have been recently sealed.

5. VIEW OF PRINCIPAL SPILLWAY FROM LEFT ABUTMENT.

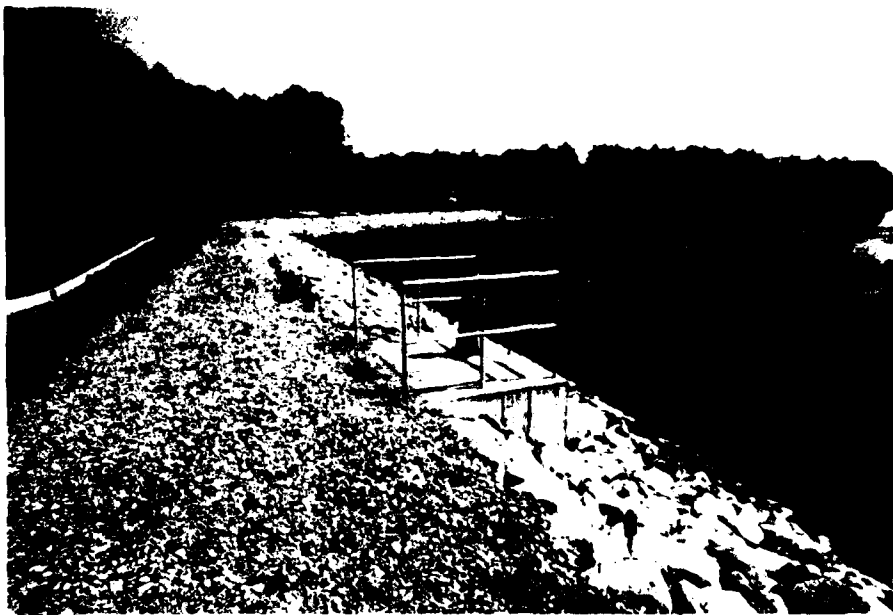
- c. Appurtenant Structures - The visible portions of the low level outlet works, as shown in Photos 8 and 9, are in excellent condition. Only some slight efflorescence was observed on the interior of the control vault. The fishway shown in Photos 10 and 11 was also noted to be in excellent condition. Some minor logs were observed partially obstructing the intake and they were removed during the inspection. One section of hand railing on the right hand side of the intake accessway has been vandalized.

8. RESERVOIR DRAIN GATE OPERATOR AND TOP OF ACCESS VAULT.

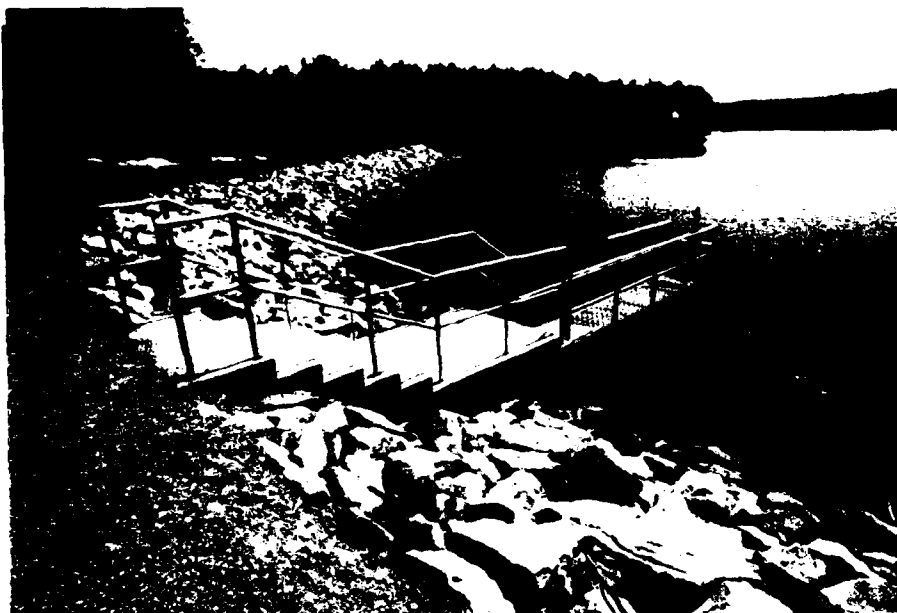
10. FISHWAY INLET STRUCTURE NEAR RIGHT ABUTMENT OF DAM.

- (3) Locate and maintain all existing piezometers. Monitor piezometers on a regular basis. Long term changes in piezometer water levels may indicate the need for maintenance of the toe drain system.
- (4) Restore the fishway accessway railing.
- (5) Clear brush from the emergency spillway discharge channel.
- (6) Establish an access way to the emergency spillway to facilitate its maintenance.
- (7) Remove weeds and brush from riprap and crushed stone sections of dam to insure that the growth does not become unmanageable.
- (8) Remove loose stones and boulders from the principal spillway discharge channel.
- (9) Develop a formal operation and maintenance manual for the facility.
- (10) Establish an emergency preparedness plan and warning system in cooperation with downstream officials and institute a program of biennial technical inspections.

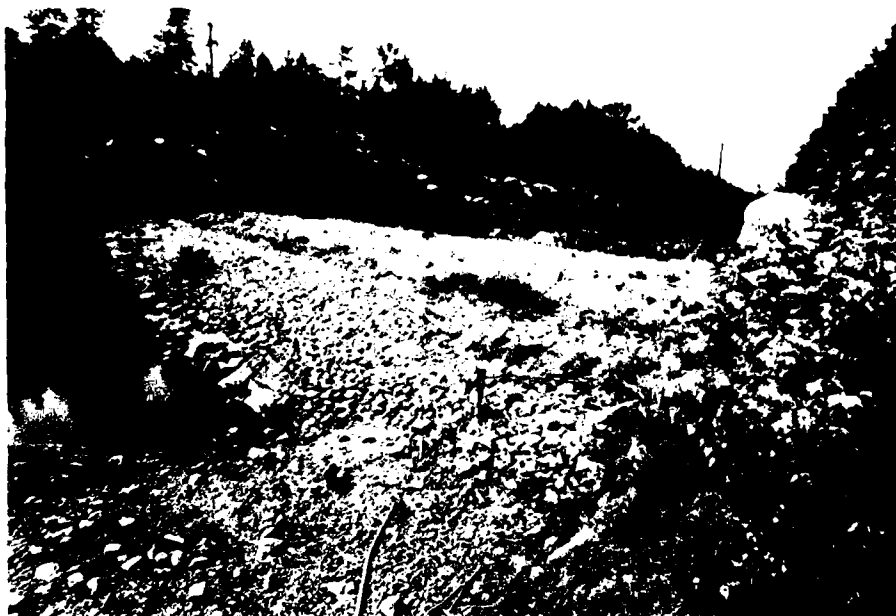
12. OVERVIEW OF EMERGENCY SPILLWAY FROM RIGHT ABUTMENT.
